## The AN/GRC-106

### History & Characteristics

### Maintenance

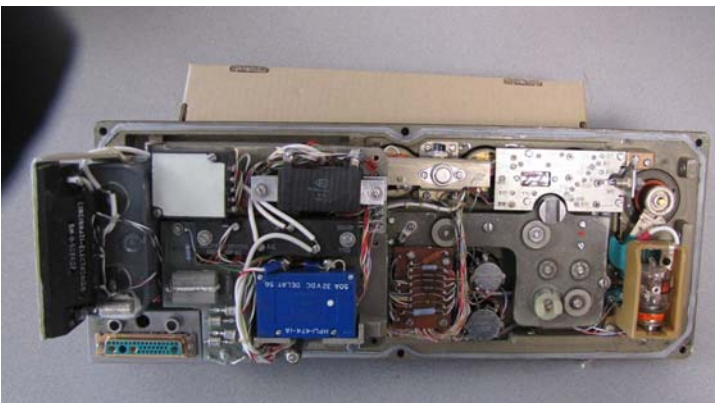
Some less common items to fail include the main circuit breaker not resetting, shown in Figure 7, the “whip/50 ohm switch” on the 2A1 front panel, the power relay 2A1A2K1, defective “tune and test” meters, and the 2A7 relay module. Zener diodes 2A1A1VR1, VR2 and VR3 also have a high failure rate due to the high voltage and heat sinking.
