# Badrestorer's Illustrated Guide to Restoring the Zenith Trans-Oceanic H500

Written and Photographed by  
John Kopp

Edited by  
Ed Morris

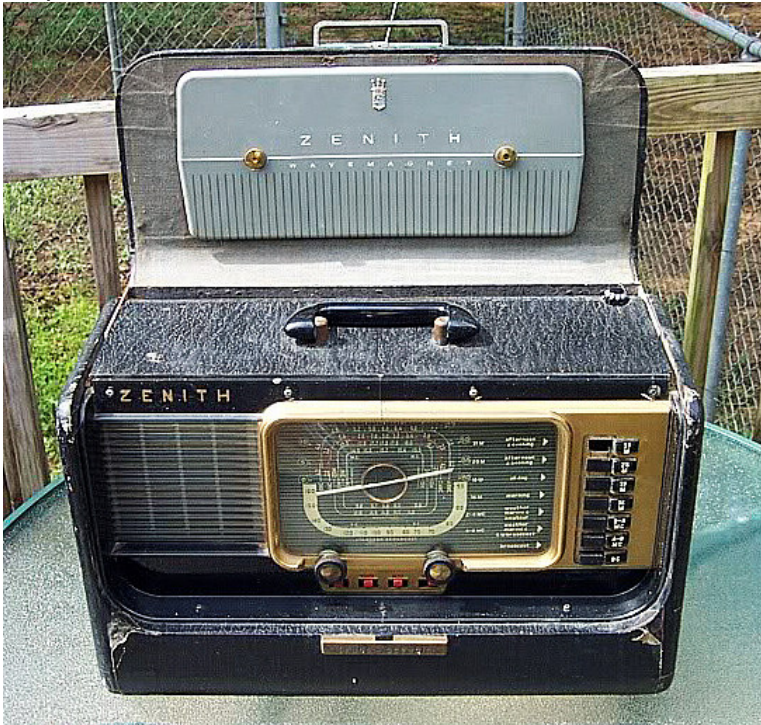
Here it is, folks. All in all (so far) I'd say this old radio is in pretty good shape---for the shape she's in:

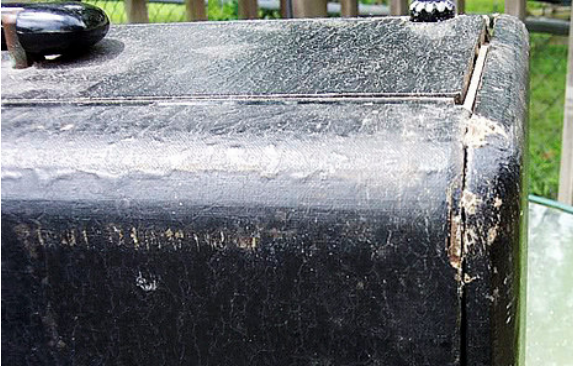
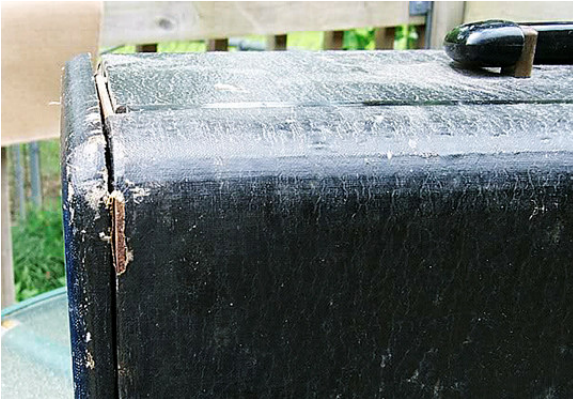
The right and left front top corners have normal wear and tear:

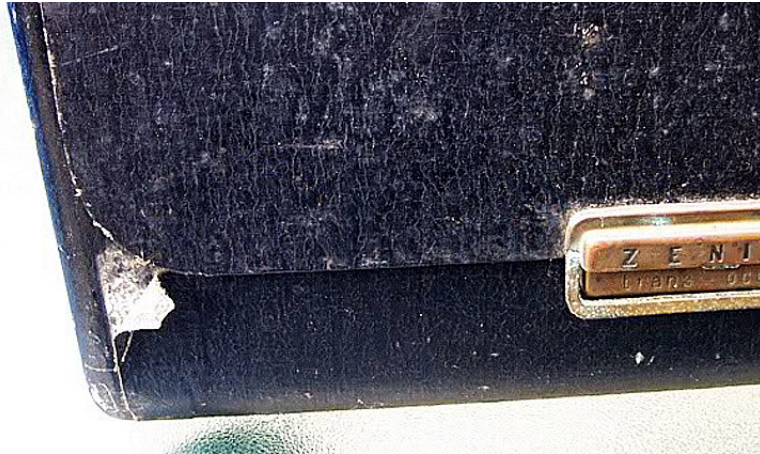
There's a little peeling at the bottom of both front corners, but no big deal:

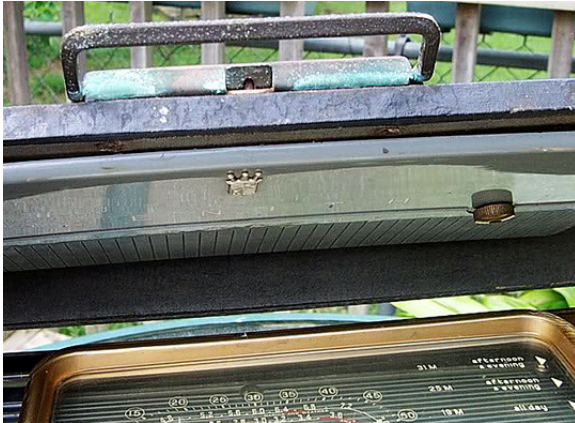
The brass front latch is very corroded. I'll have to get on that puppy right away:

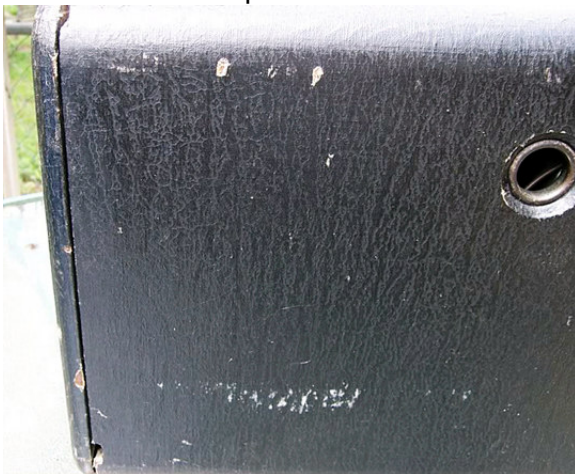
The back has a couple of small nicks:

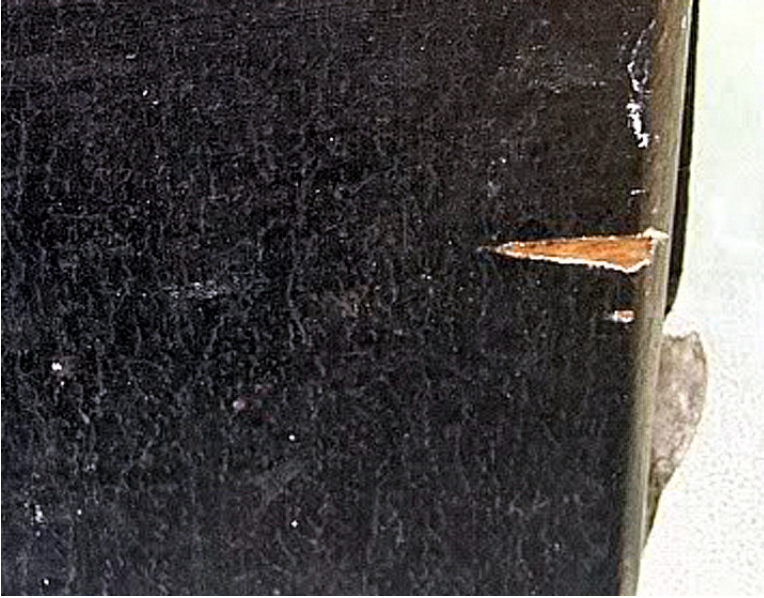
The left side has a larger gouge, but still no big thing:

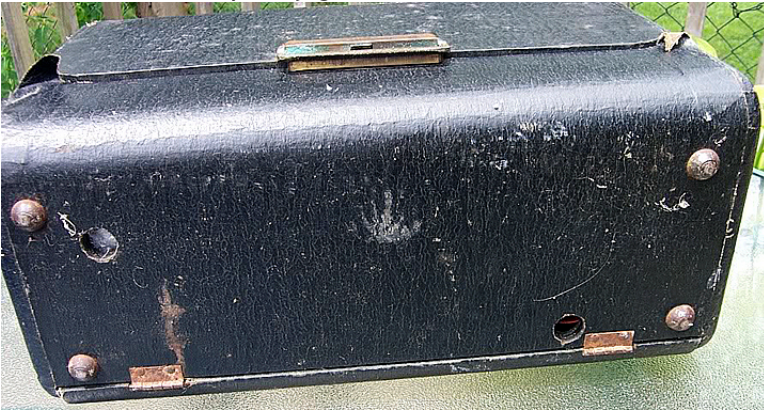
The bottom looks pretty good:

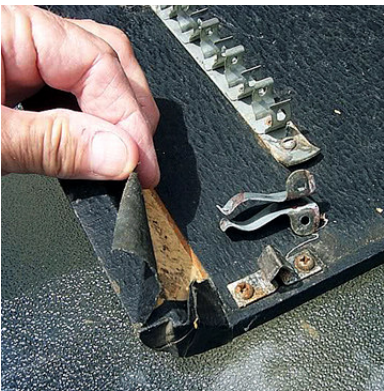
Inside of the back cover there's more peeling and both hinges are very rusty. Easy to deal with:

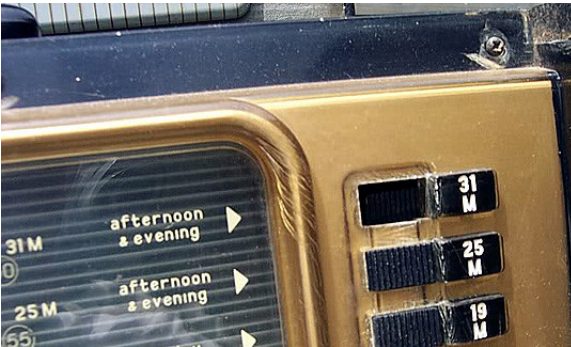
The top band button has been pushed all the way through. Luckily, I can see it's still in there:

You'll recall that during our initial inspection of this radio we found the top band switch button pushed all the way through and into the cabinet, and the second button nearly the same way. I remember asking myself what self-respecting engineer would design a radio so the buttons could do that. It turns out that an engineer would not. The problem was caused by a missing coil tower support bracket:

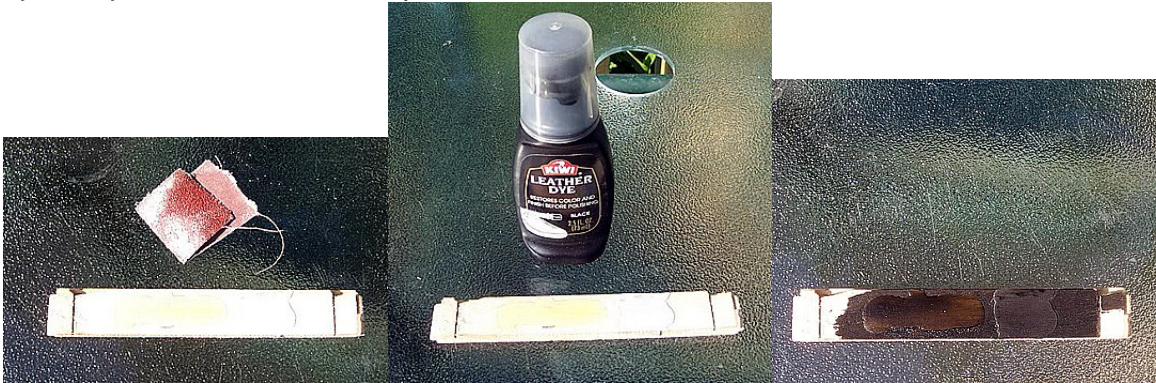
The Elmer's and J-B took about the same time to dry...and both dried really hard. But the Elmer's was much more difficult to sand. It sanded ok, but not as quickly and easily as the J-B. Leather dye was then liberally applied to both and allowed to dry. Both took the

dye fairly well, which was a surprise to me:

Conclusion: Both Elmer's Wood Glue and J-B Weld will work equally well for repairing/patching Transoceanic Stag covering. But the Elmer's is a bit harder to work with. That's my story and I'm stickin' to it.

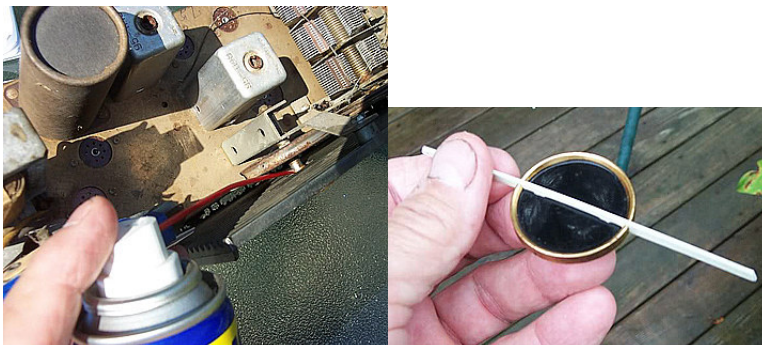
As with many vintage radios, removing the dial scale means first removing the dial needle...but this needle wouldn't budge. I almost hauled out the trusty Bernz-O-Matic torch, but in the end a shower of good old WD-40 saved the day. By the way...be careful pulling the needle off the shaft. The round center gold part bends easily. Don't ask how I know that:

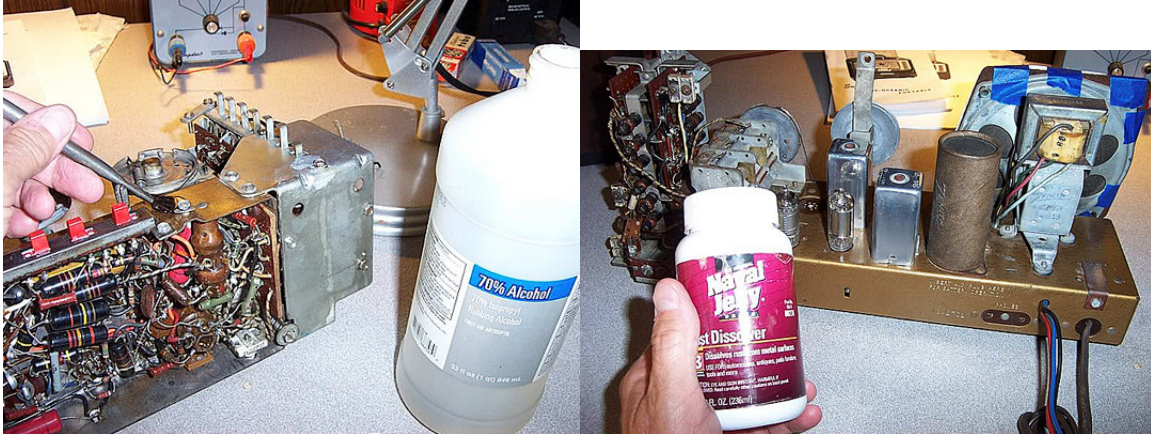
This chassis is in excellent shape...having only light dust and a couple of very small rust spots. I'm really thankful for that. Some alcohol, a couple drops of Navel Jelly here and there (and a little Brasso) took care of everything:

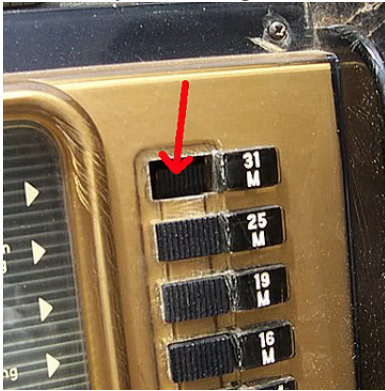
The bracket's purpose is to prevent the tower from bending/leaning backward as the bandswitch buttons are pressed, and its lack thereof has been causing part of my bandswitch difficulties. The tower was moving backward, slightly jamming the bottom of the flat shaft that runs down its center. It was pure luck that I found out about the bracket. An ebay seller's photo told the tale...to include showing me there was also a missing Wavemagnet antenna wire clip:

Back in August, at the very beginning of this thread, I received a PM from forum member, R-520/URR (ShawnK), of British Columbia, Canada, kindly offering to send me any needed H-500 parts. I really appreciated his offer. Good to his word, he provided the missing bracket, two red suction cups, the small silver clip in the above photo...and a junk coil tower. It continually astonishes me how willing our members are to pitch in and help out each other.

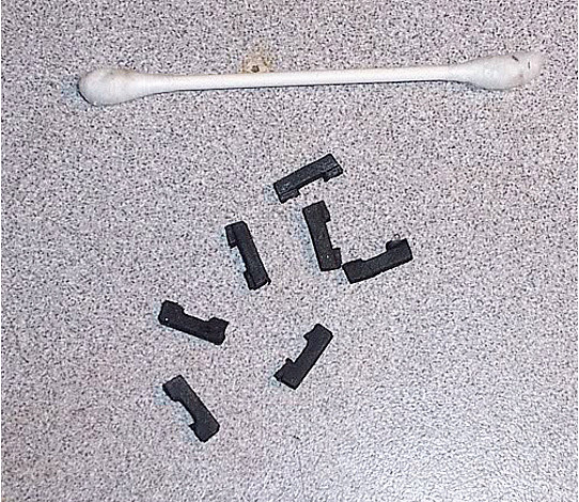
(The photo below shows) the small rubber bumpers that had fallen out of the tower. At the time I couldn't figure out how to get them back in. Guess what?...it still ain't gonna happen:

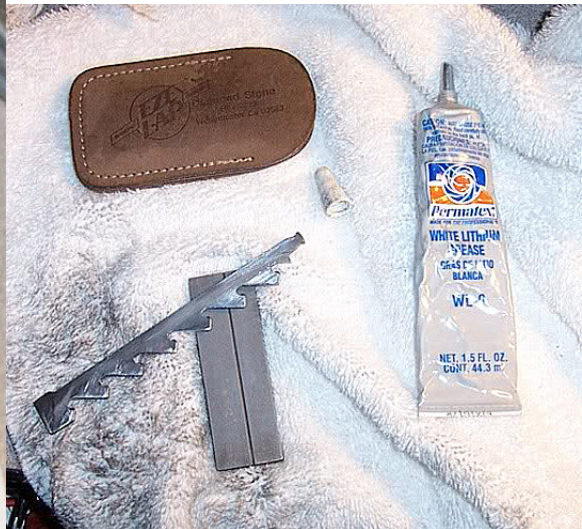
Dry-fitting proved the theory correct. It wasn't dragging quite so badly as the original shaft, but it was enough to keep the band switches from working properly. So what to do?

The only thing I could think of was to haul out my diamond impregnated sharpening stone and started stropping away, first on one side, then the other...then do another dry-fit. This went on for 40-minutes, but when it was over the shaft, with the help of a light coat of

white lithium grease, slipped in and out with total ease. (But) for some reason the band switches stopped locking into place. I lifted while pressing...pushed down while pressing...moved them left and right while pressing. Nothing worked. They just kept popping back out. I was not a happy camper.

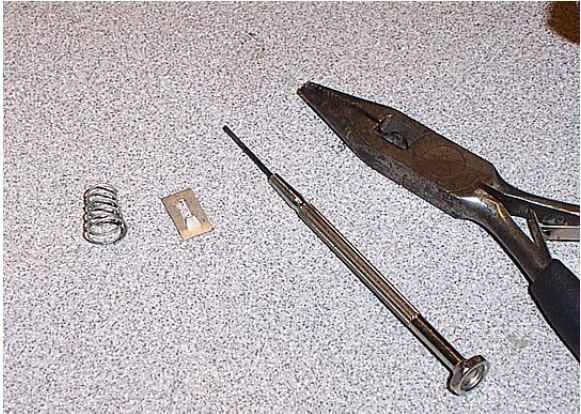
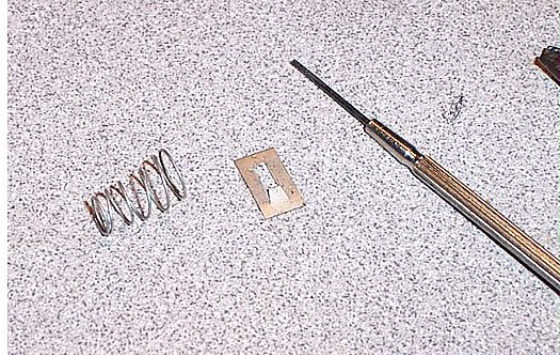
A small pair of needle-nose pliers and a very small jewelers screwdriver made it easy to remove both:

The spring had apparently collapsed from age, so I stretched it to almost twice its length. (Note: The amount of stretch was precisely calculated by a series of highly sophisticated mathematical formulas).

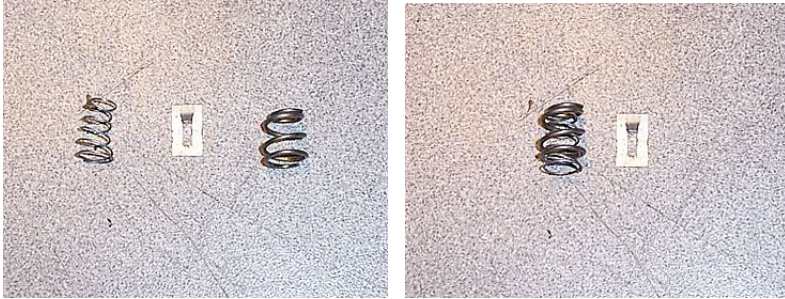
I dug around in my junk bins and came up with a thicker, stronger spring...surprisingly, its length and diameter being pretty darn close to the original. Even a blind hog finds an acorn once in a while:

So I stuck the old spring inside the new one and installed the combination on the shaft. No dice. Far too much tension. The band switches barely budged. In the end I was able to use the new spring by cutting off the top loop. Then came a little bending, twisting, spreading, shaping, etc. Works fine - last a long time: 😊

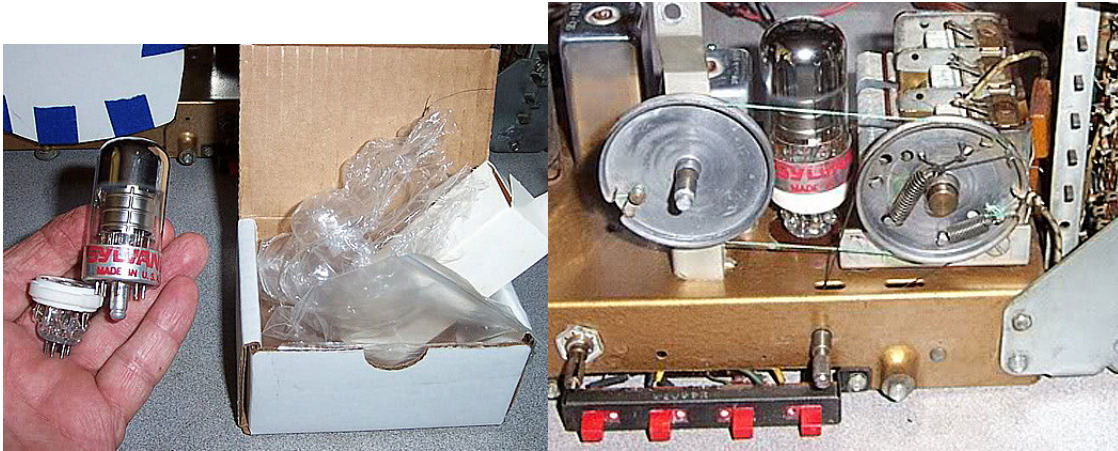
what I received from Bill Turner\*, the replacement for my missing 1L6 converter. Though big, it looks pretty spiffy sitting in there:

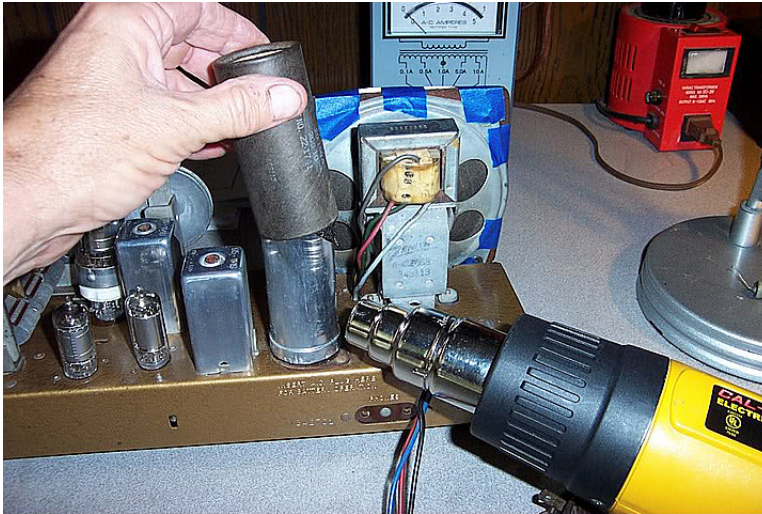
I decided to re-stuff the can without removing any of the existing wires or drilling out the rivets. The can would stay put. Therefore, it became time for a nice cup of coffee and a bit of skull-braining. The first problem was to figure out what to do about the cardboard sleeve. It had to come off and not sustain any damage in the process. I thought the answer might be the ole heat gun.

I didn't know what type of glue was holding the sleeve in place, but hoped it would soften under heat. So I poured the heat to the outside, keeping the gun constantly moving and being very careful not to set the thing on fire. It got pretty hot, but no smoke appeared. After about 45 seconds I wrapped my hand around the sleeve, but not for very long...know whadda mean, Vern? I let it cool for a few seconds longer, then tried again. Son-of-a-gun...the sleeve twisted off just as easy as you please...without so much as a wrinkle.

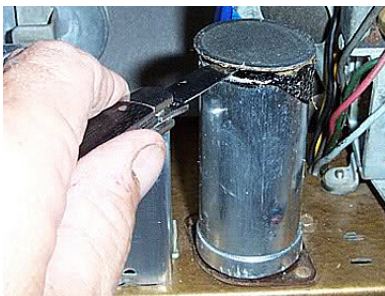
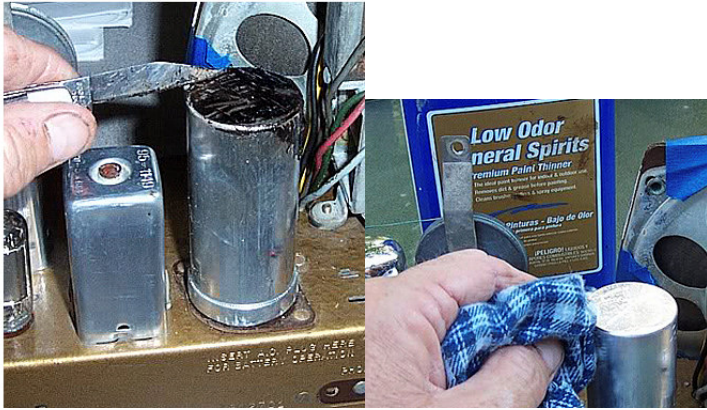
The round disk remained stuck to the top, but my pocketknife helped with that:

The sleeve was glued on by a tar-like substance, but not exactly tar. It's almost like tar and wax mixed together. My knife blade removed the excess. Mineral Spirits made the rest go away. It peeled right off the round cap...no effort at all.

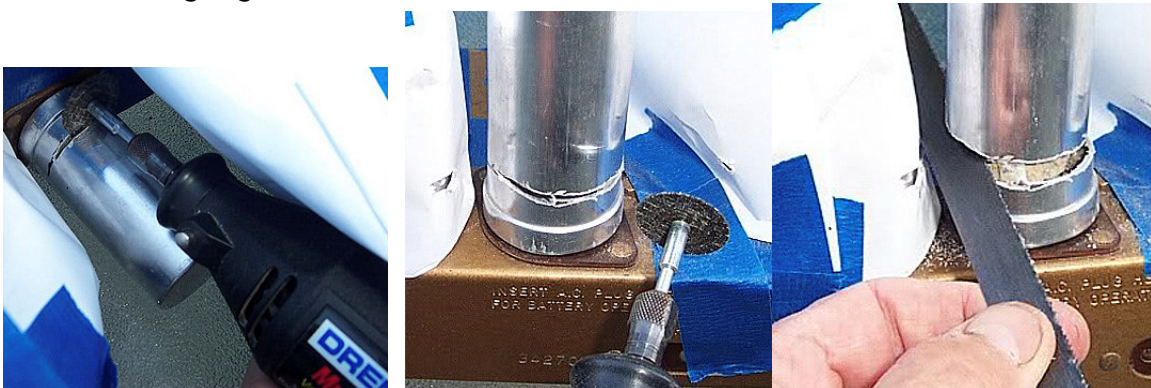
It was now make or break time. Out came the Dremel Tool, the chassis was laid on its side, and the cutting began:

There's not much room between the IF and filter cans, so the last 1/4 inch or so was done by hand with a hack saw blade cutting at a slight angle.

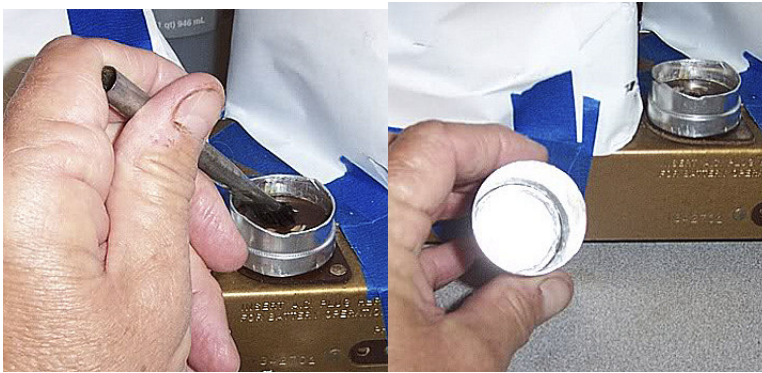
The cut edges were sanded smooth, mineral spirits removed the remaining cement from inside the top, and both sections were cleaned with alcohol. The can is now ready for restuff.

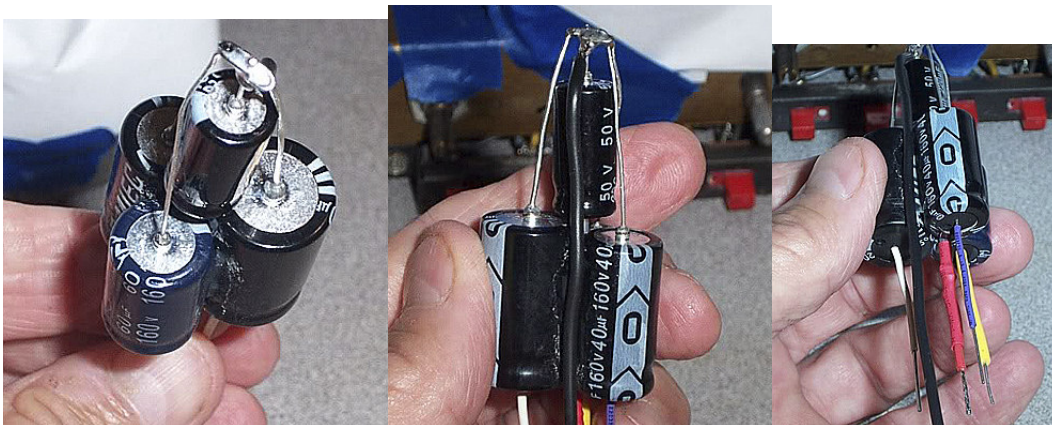
How to configure the four new filter caps (220uf, 60uf, 40uf and 20uf) for a good solid installation inside the filter can became the next headache. So I set the caps on the

workbench and maneuvered them this way, that way and a hundred other ways looking for the best arrangement. I'm sure many of you could have done better, but with the help

of a little Super Glue Gel, this is the setup I came up with (see photos, above and below).

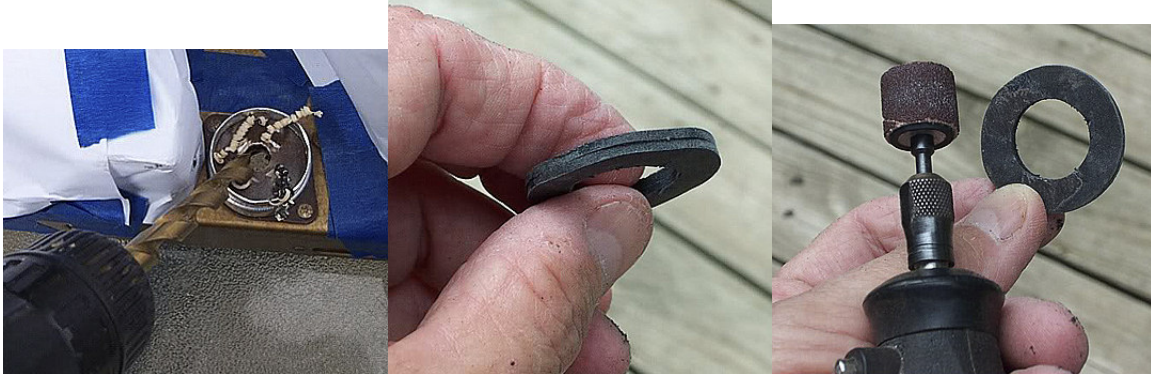
But I did encounter one small difficulty: I had drilled too small of a hole through the bottom of the filter can. The now insulated positive leads would need to be excessively bent to fit through it. Not good. So the hole was enlarged to 3/8-inch:

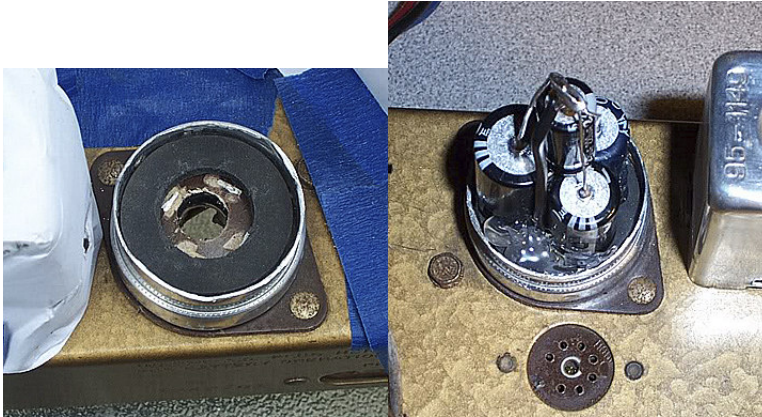
The black rubber washers were super glued to the bottom of the can and a few globs of hot glue hold the caps in place:

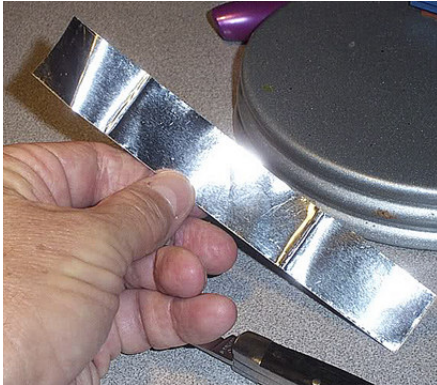
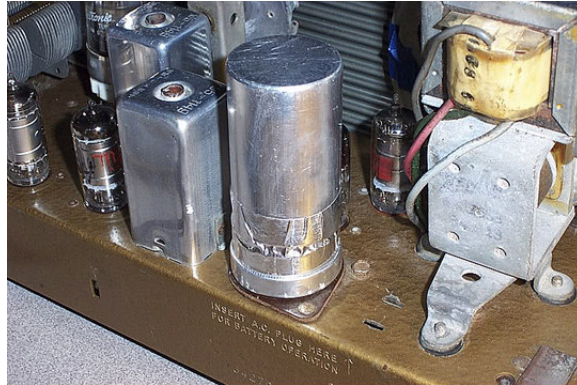
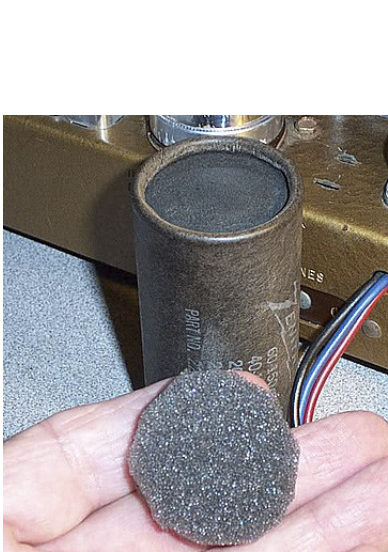
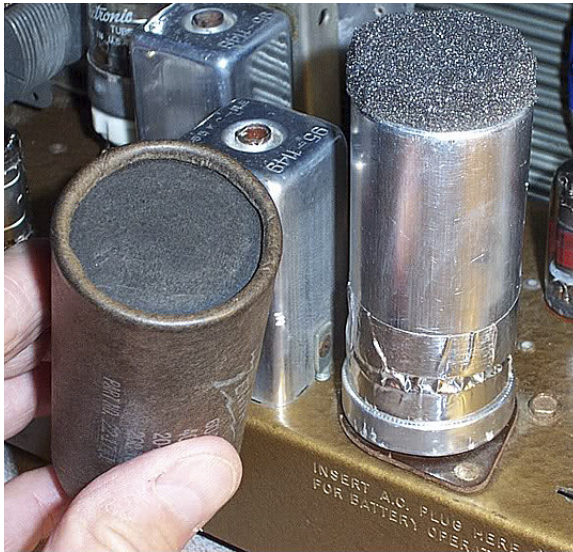
The two halves were joined with aluminum exhaust header tape. A while back another forum member recommended using it. I liked the idea, so decided to give it a try. Trust me, it works great. It's neat, clean and provides continuity, if needed.

(A disk) was cut out of a thin sheet of foam rubber. The round disk at the top of the cardboard sleeve is just pressure-fitted in there, but I decided not to glue it in place. Too

messy. Instead, the foam will sit on top of the can and apply enough pressure from the inside to hold it in place.

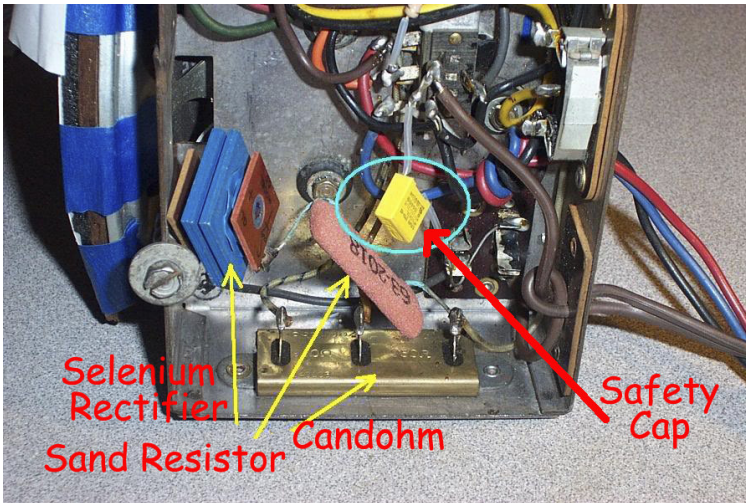
In the photo above, note the safety capacitor (green circle) installed across the AC line.

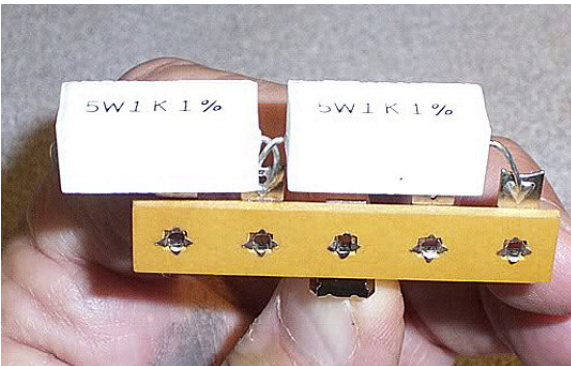
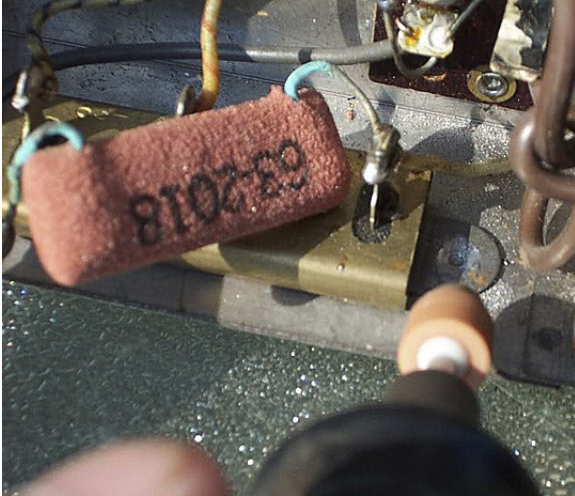
This morning the Dremel Tool and a pointed medium grit stone were used to remove the rivets holding the Candohm resistor to the chassis. That Candohm consists of two 950-ohm, 3-watt resistors. They'll be replaced by two 1k-ohm, 5-watters.

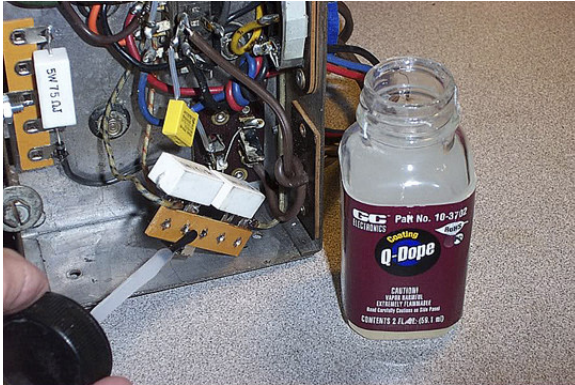
High filament voltage, low filament voltage...all I want is enough voltage in the right places so this thing will start playing again. With that in mind, what say we get back to the biz of restoration? The wires from the Candohm and selenium rectifier were removed and reconnected to the terminal strips. I then became concerned about accidentally touching and

grounding one of the double resistor connection points to the chassis, so before going any further a liberal coating of Q-Dope was applied to the backside:

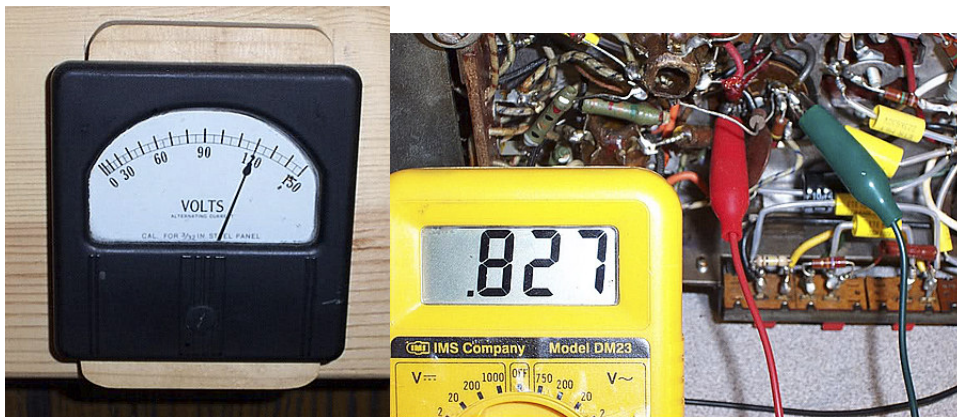
The remaining four gator wires look confusing, but just know that they connect the white 5-watt resistor, the 3-watt sand resistor and the rectifier diode all in series with one another (located after the diode). The correct resistance for the white resistor is what we're after. It all began with 300 ohms:

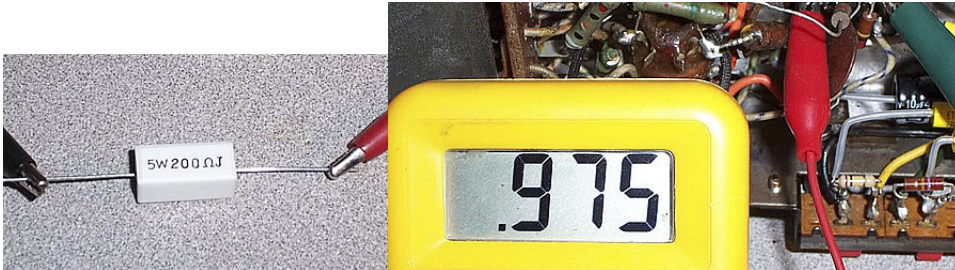
I slowly increased the variac voltage, all the while keeping a very, very close eye on the multimeter. I did not want that filament voltage to go above 1.4vdc. The variac reached 120vac. But the filament voltage wasn't high enough. I needed to decrease the size of the resistor and try again. 200 ohms threw its hat into the ring:

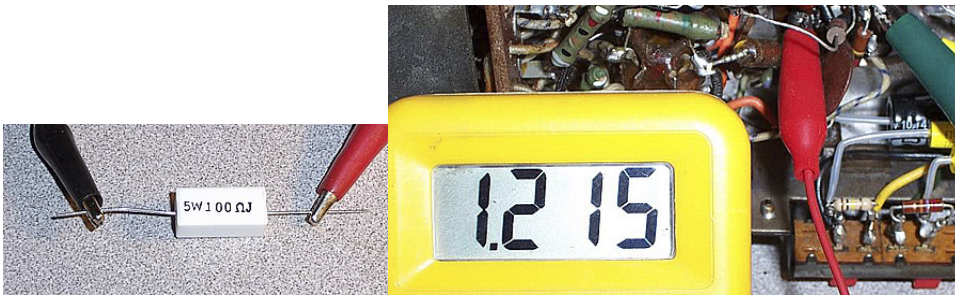
Again at 120vac the filament voltage was not high enough. I needed to further decrease the resistance. In went 100 ohms:

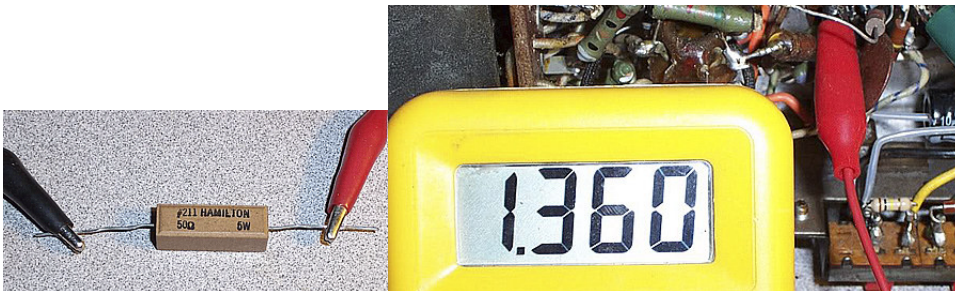
Things were getting closer, so very, very slowly the variac voltage was increased. I was surprised to again reach 120vac with the filament voltage still not high enough...no cigar yet:

When all was said and done, it looked like 50 ohms would achieve the filament voltage I wanted.

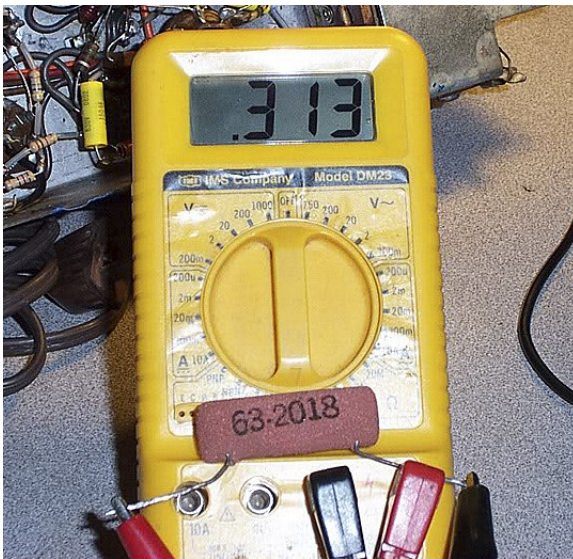
This is what the Zipohm was reading before I soldered it back in the chassis, so I figured a 300 ohm 5-watt replacement would do. Wrong!:

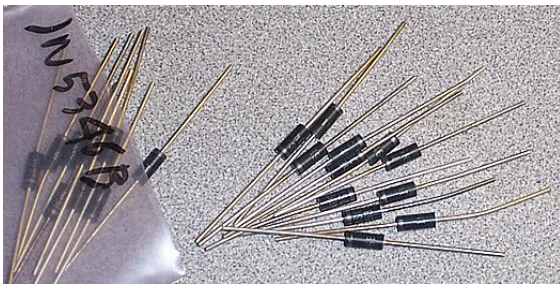
We'll... be installing one of these 9.1volt, 5-watt zener diodes (1N5346B) in the filament string, and closing up the filter can. Prepare to be bored once more.

Sometimes by design a zener will short and pass voltage to different parts of the circuit to be used by other components. At other times the excess voltage is simply gotten rid of by sending it straight to ground. Zener diodes come in various voltage ratings and different wattages.

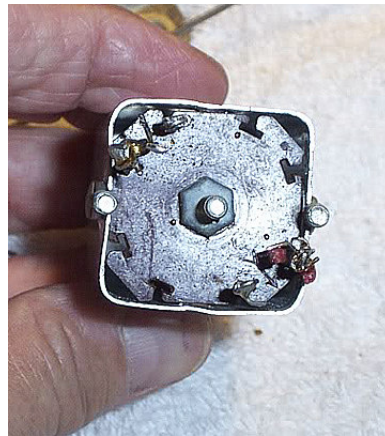
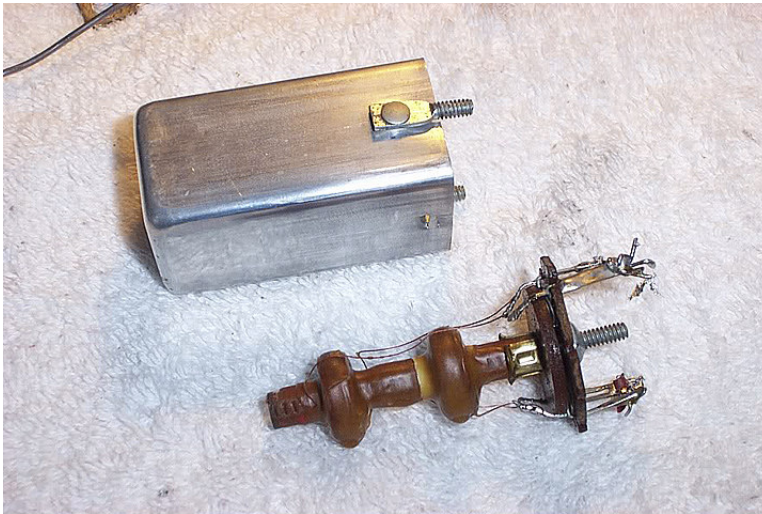
This Transoceanic is beginning to try my patience. (One) problem no sooner gets fixed and WHAM!...up pops something else, no doubt caused/aggravated by the heavy rains we've been experiencing in Arkansas. It rained for almost a month straight. Anyway, here's my next headache. Can you say "Silver Mica Disease?"

After taking several close-ups of the IF can connections, and also making a couple of sketches, the first can was removed from the chassis. Two of the bottom edges are slightly crimped to hold the coil in place. A pair of duckbill pliers will flatten them out. The coil (transformer) should then slide out easily. From this point on it's important to work very carefully, very slowly...taking your time...thinking things out:

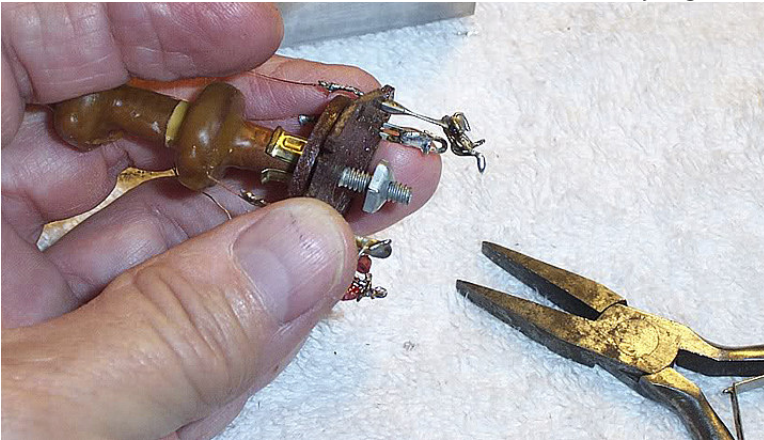
Now remove the nut at the bottom. It's not on very tight:

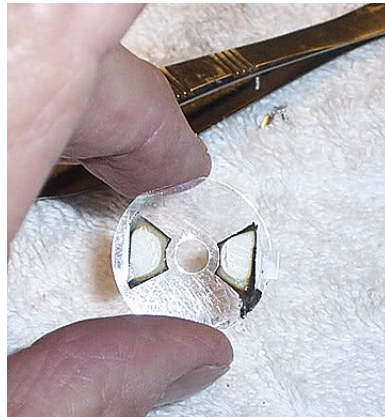
That brown disk will now lift right off...but be very careful around those thin wires. Coordinate those shakes. With a pair of tweezers, gently slip out the small round piece of mica. That black stuff you see here has to go away. It's the migration:

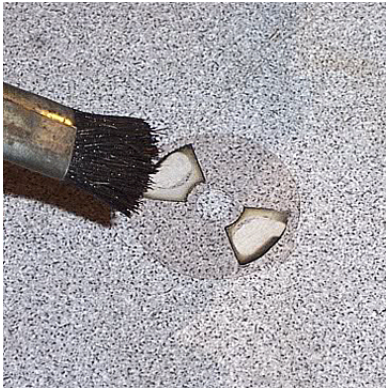
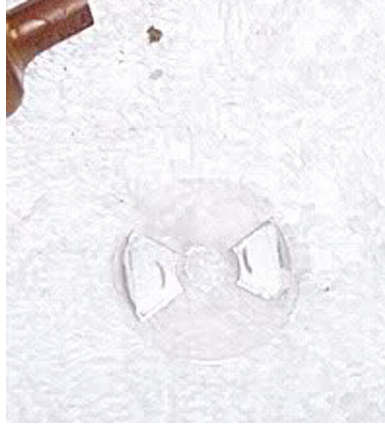
Clean both sides with alcohol. It'll remove quite a bit, but not all (left). Not long ago one

of our forum members said he used a pencil eraser to clean away migration. Sounded like a good idea, so I tried it...but it had to be done very gently. Turned out pretty good (above, right).

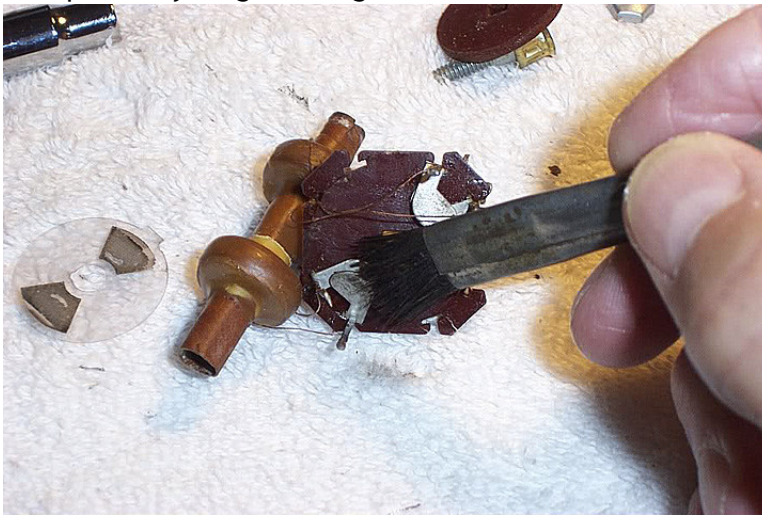
Now put everything back together in reverse order and all should be well:

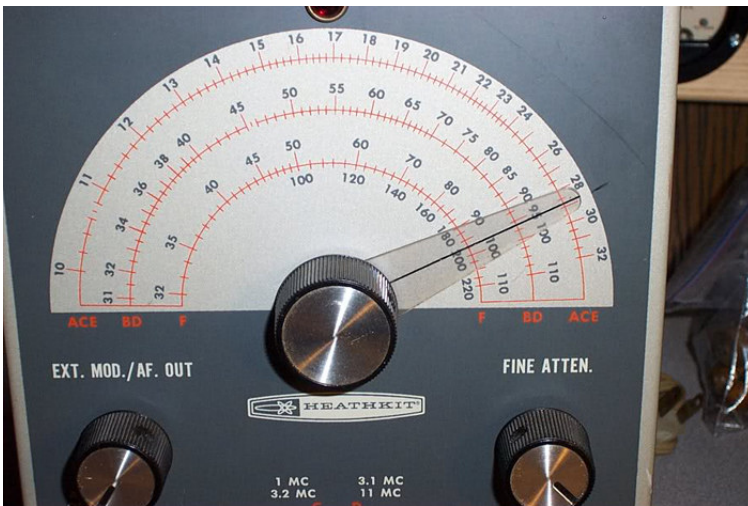
Per the alignment instructions, the signal generator was adjusted to 9.6Mc:

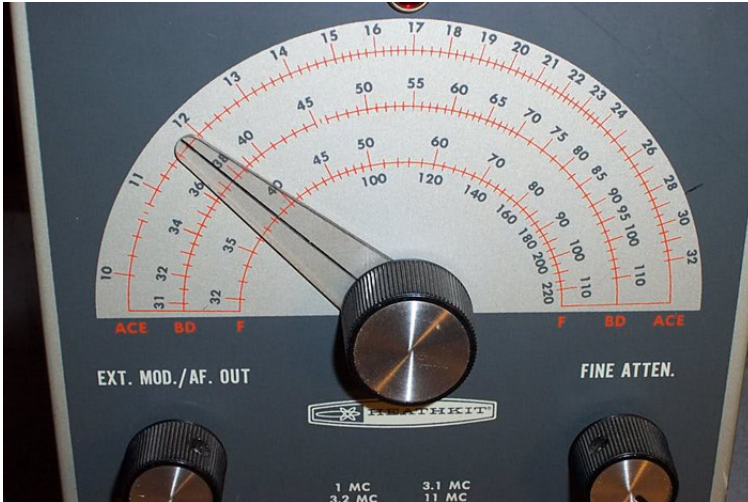
The signal generator was adjusted to 11.8Mc:

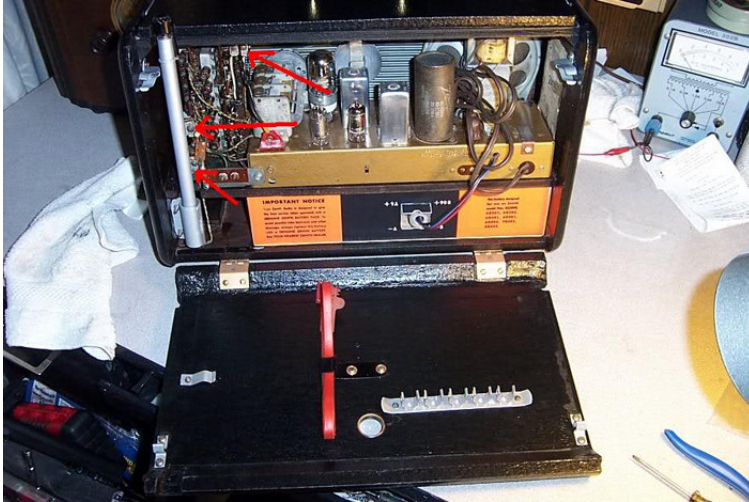
The same alignment procedure was done for the 19 and 16-meter bands. However, alignment of the 2-4 Mc band does not require coil-tweaking. Instead, trimmer capacitors C-33B, C36B & C37B (osc., det. & ant) are adjusted, but the mechanics remained the same. Just follow the alignment instructions.

The trimmers are located here. I just realized this isn't such a hot pic. Tomorrow I'll replace it with a better one:

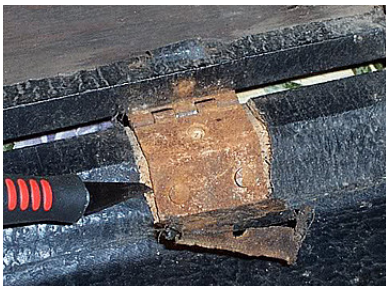
The Stag had to be cut and peeled back to get at the two lower screws. Uh-oh, they're not screws. They're some sort of fastener:

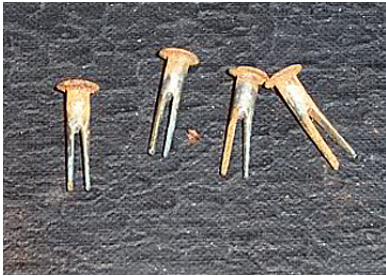
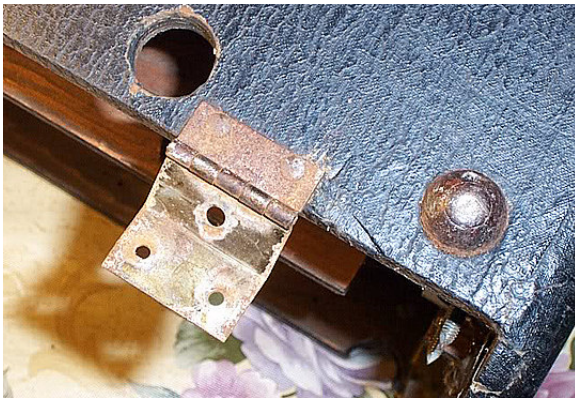
The other half of the hinges were also fastened to the cabinet by the clothespin things,

but on the other side of the wood the ends were bent over. It looked like it was done with some sort of press.

Removing them was out of the question. It would cause too much damage to the wood:

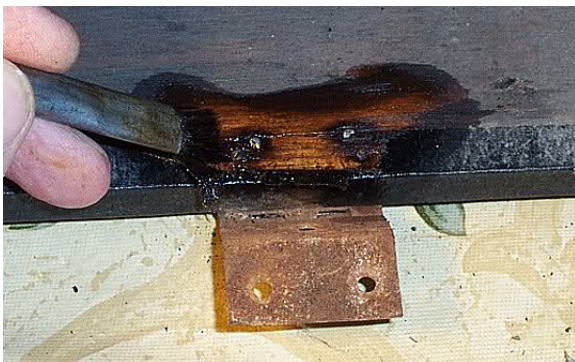
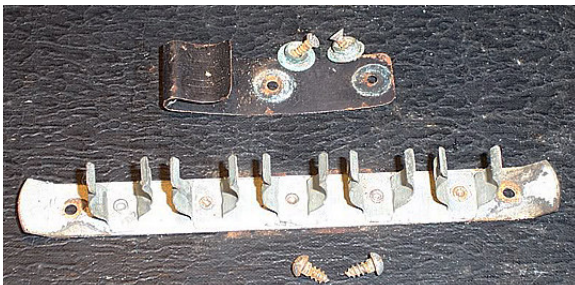
This shows the bent over ends:

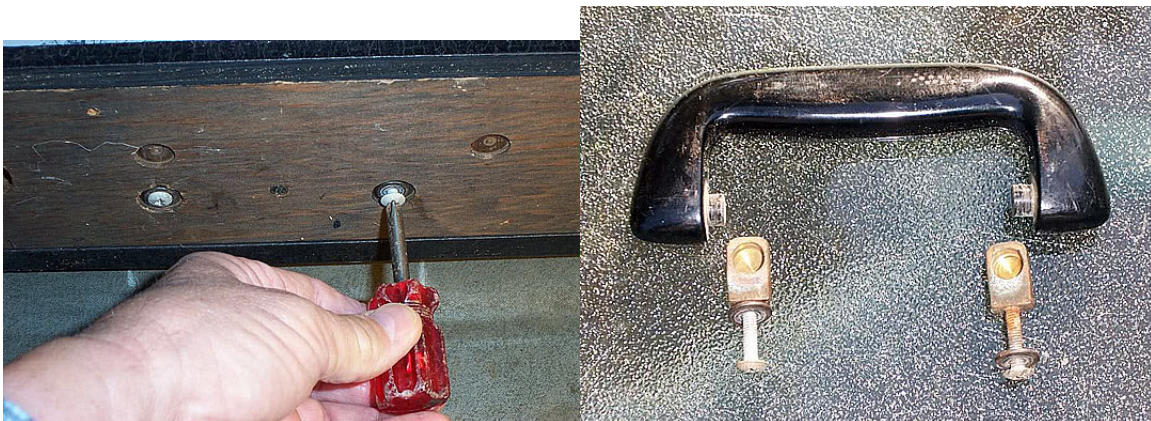
With the hinges looking better, it was time to do some serious ripping and tearing. The carrying handle was next to come off. It's held on by two large screws:

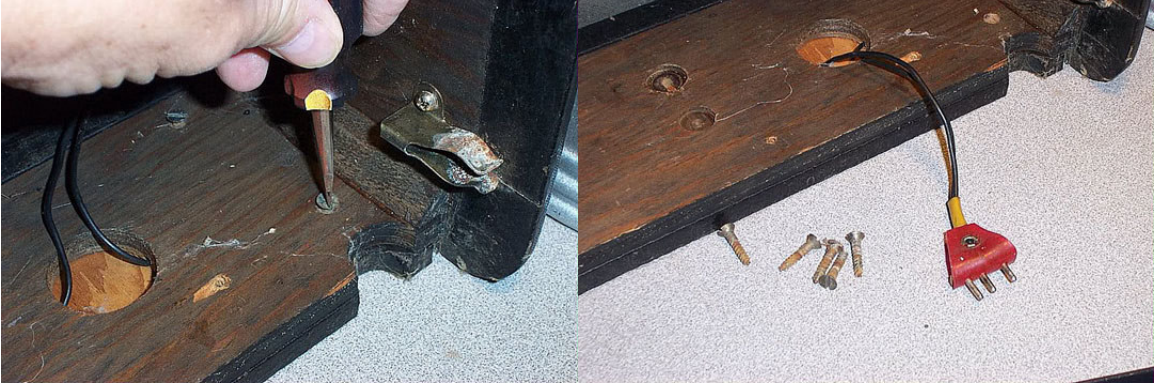
The top of the cabinet consists of two pieces of plywood screwed together with five small wood screws. The wires from the Wavemagnet antenna sit in a slot between them. The screws were removed:

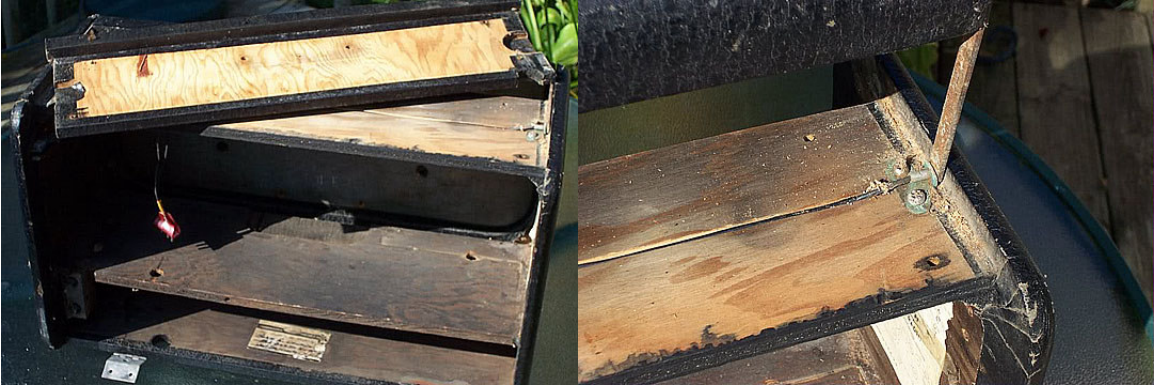
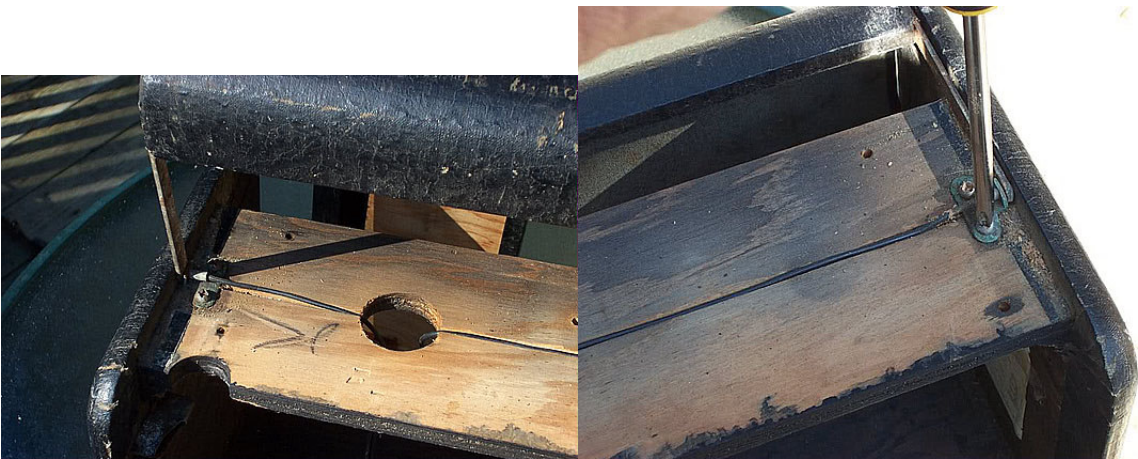
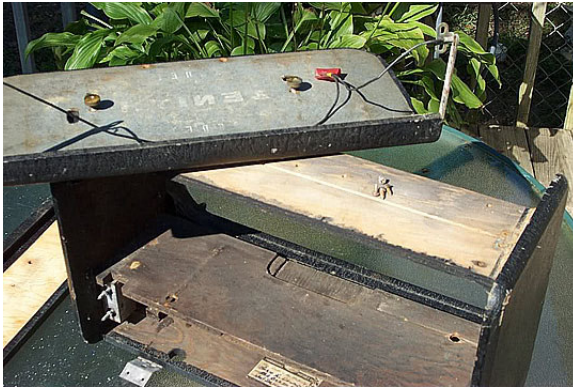
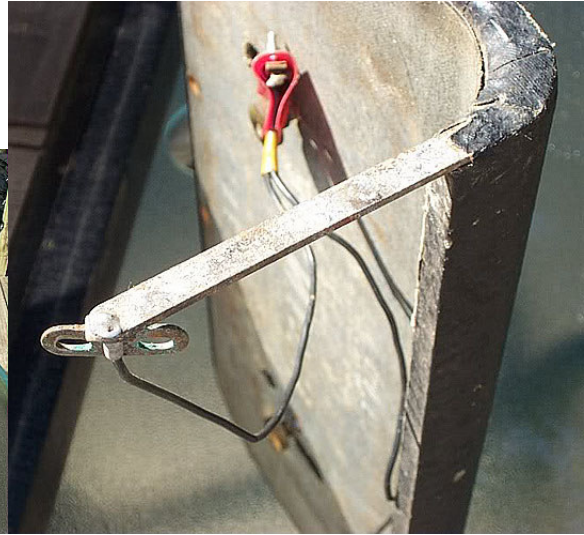
This series of pics shows the top removed, the slot, the wires and how they're connected to the front cover hinge arms. Pretty cool idea on Zenith's part:

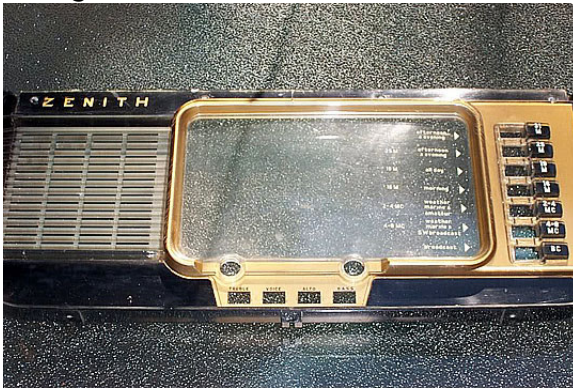
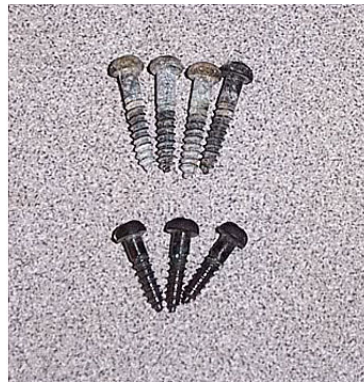
The plastic dial cover was removed. Note that three of the screws are smaller. They go through the three holes in the bottom of the cover:
