# Badrestorer's Illustrated Guide to Restoring the Zenith Trans-Oceanic H500

Written and Photographed by  
John Kopp

Edited by  
Ed Morris

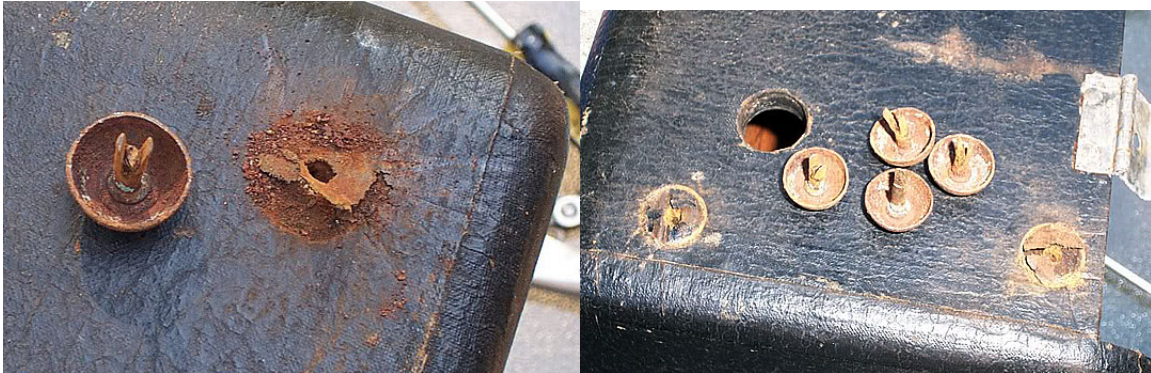
Two of them had a lot of rust underneath:

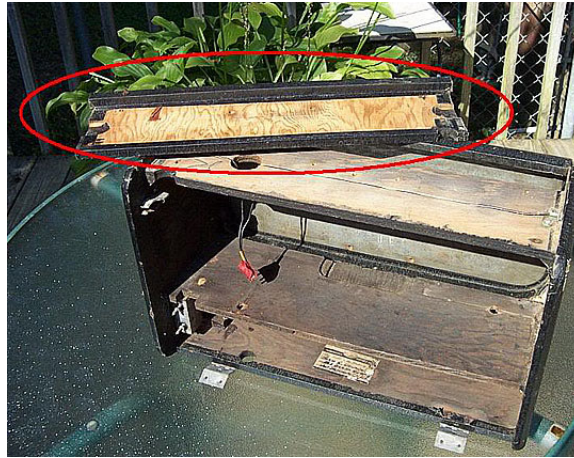
With the feet removed, it was finally time to do a little experimental cleaning and repair work. The top would be the first victim:

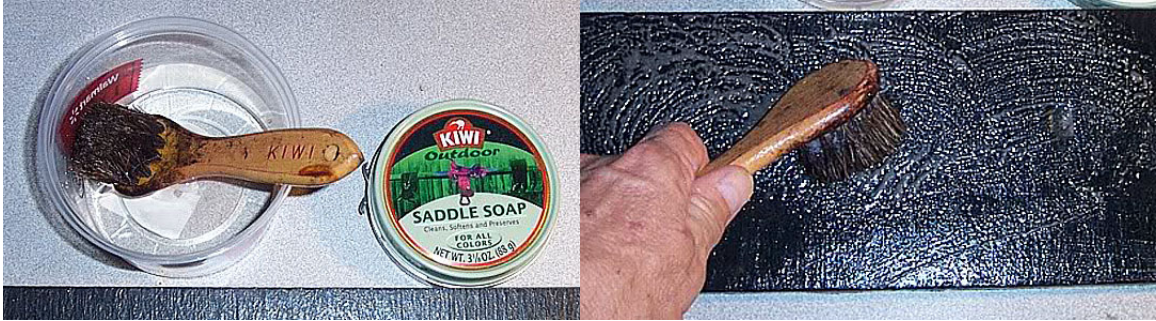
While preparing for this tread I must have come across a million different ideas on how to clean Transoceanic Stag...steel wool to dish soap to mineral spirits. But I'm a joker who's stuck in his ways. For me, the answer was elbow grease and good ole Saddle Soap:

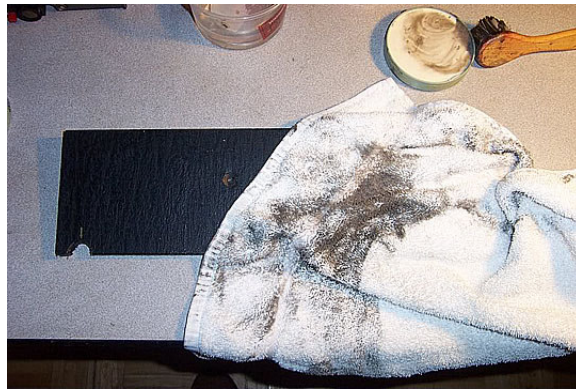
A lot of grime came off that little bit of Stag:

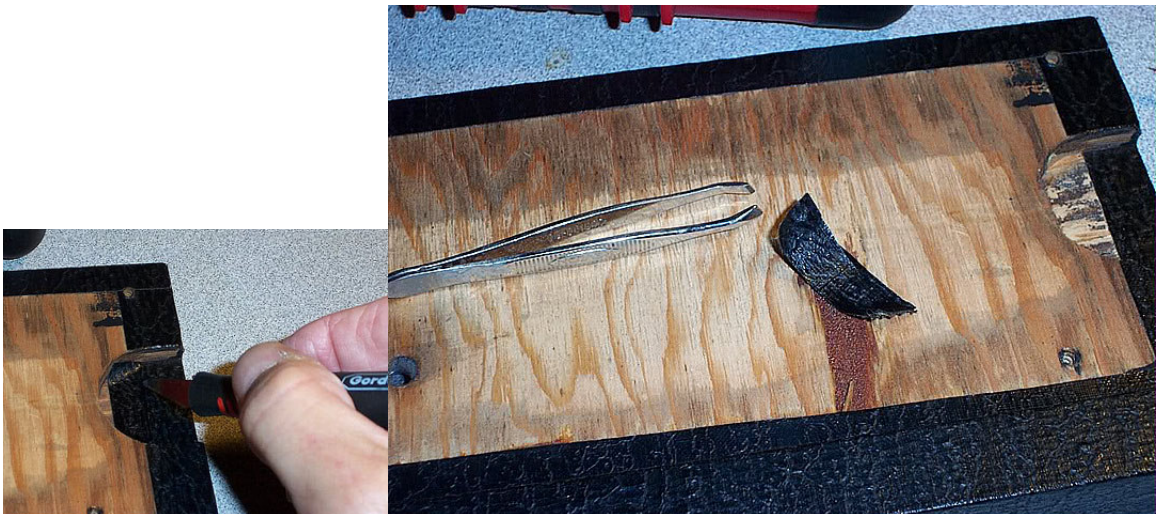
With the cleaning finished, I used my X-acto knife to lop off a couple pieces of excess Stag. I probably won't need them for patchwork...but one never knows:

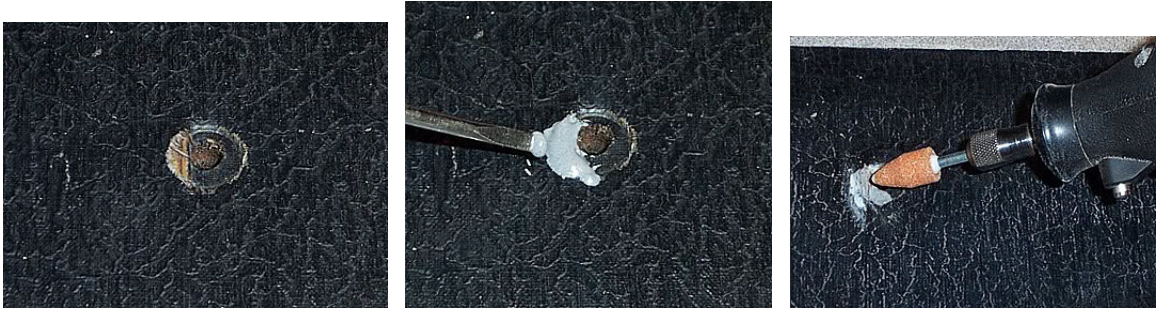
The Stag on this top is in very good shape, missing only a tiny bit where the carrying handle attaches. J-B Weld filled the hole.

When dry, a couple light touches with a medium grit stone (photo above, right) followed by coarse and fine sandpaper had it looking righteous. It was then given two treatments of Kiwi Leather Dye:

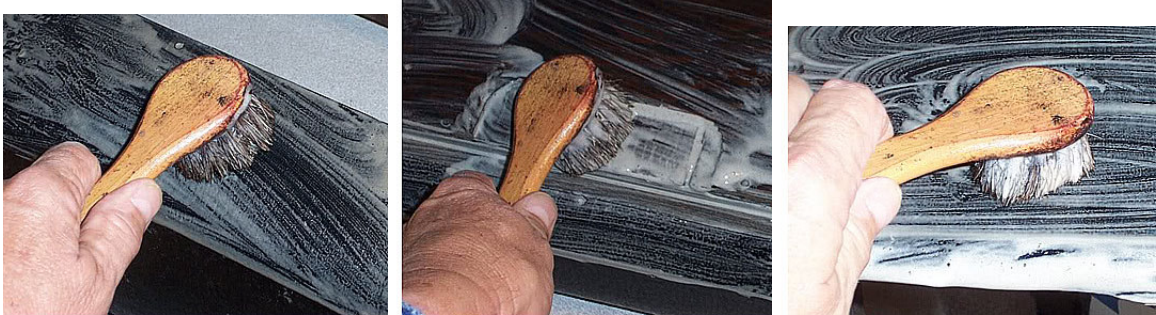
Next on the agenda was a scrub-a-dub-dub to the rest of the Stag and wood. They were pretty mangy. Saddle Soap not only does a good job of removing crud, but it also eliminates that ever-present, old radio, musty-mildew odor...and this radio had a lot of it. Some surfaces were scrubbed twice:

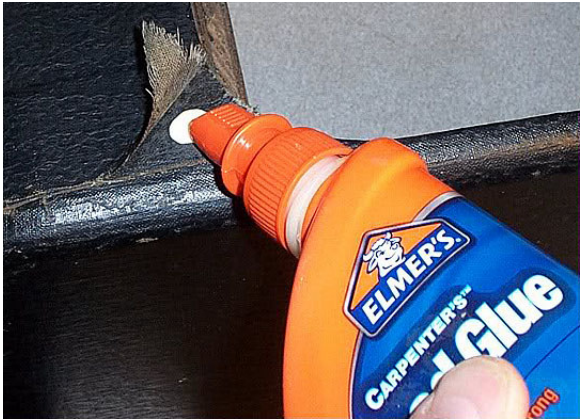
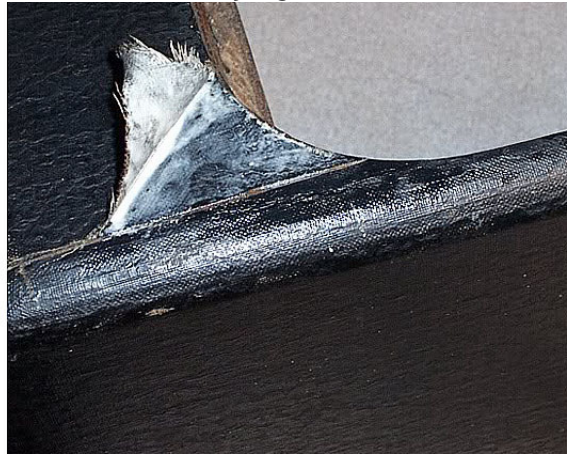
All of the loose Stag could now be glued back down. There wasn't much of it, so I decided

to just use Elmer's. It worked ok, but I suppose time will be the judge:

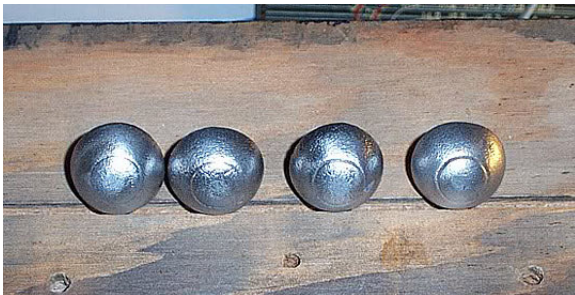
Before leaving work last night I stopped off in the company maintenance section to use the wire wheel on their big grinder. The rusty outside surfaces of the four cabinet feet were given the what-for:

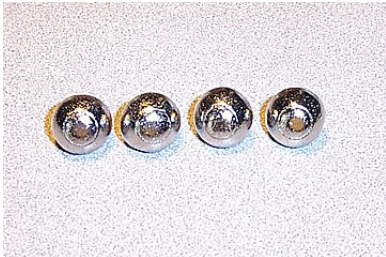
The inside surfaces were still mega-rusty, so this morning they got the Naval Jelly what-for. I poured it in, then let them soak for four hours. Tomorrow morning they'll get another hour's worth. Once again my ole buddy, Wade, the night supervisor of the chrome vats where I work, took care of me. Ain't they coooooool?:

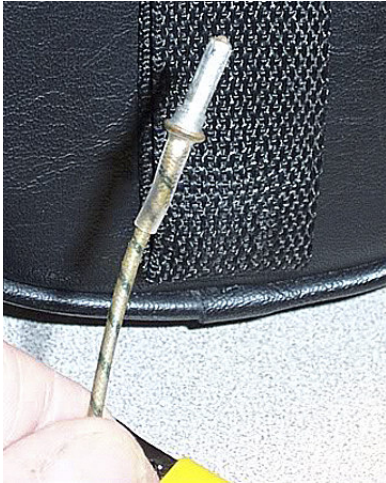
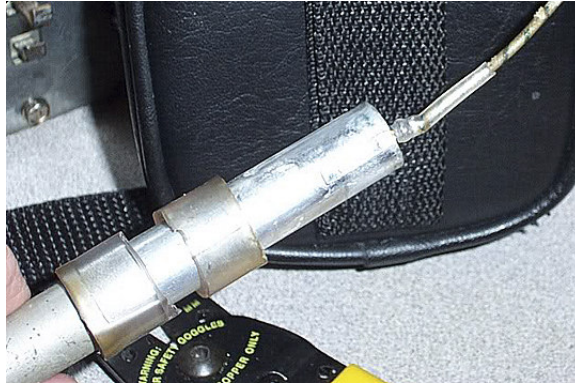
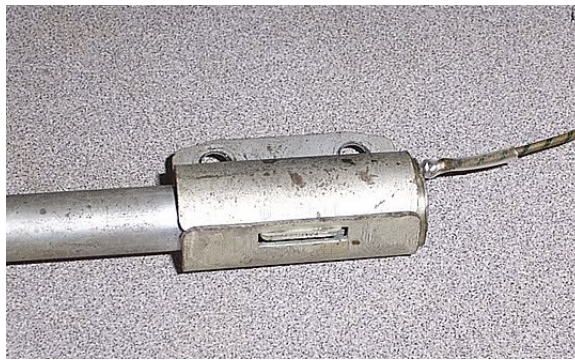
I decided to spruce up the telescopic antenna (Waverod). To help prevent further insulation fray a short piece of clear heat-shrink tubing was put on the plug end:

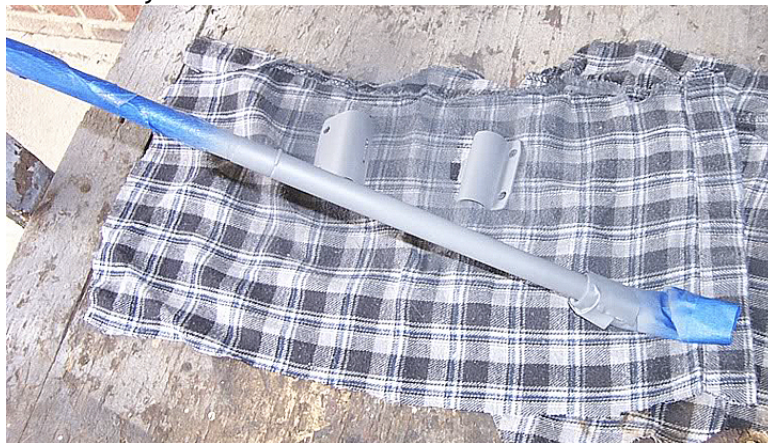
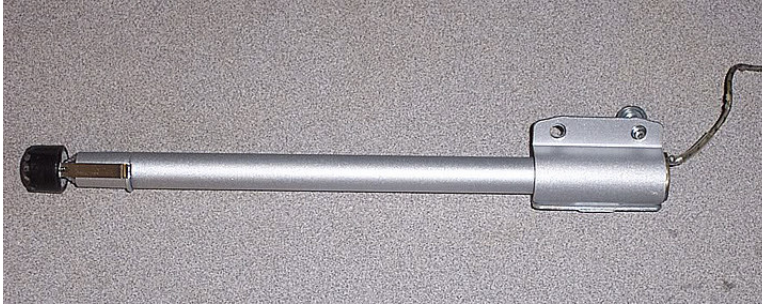
But overall the antenna still looked pretty shabby. It was resolved with 400-grit sandpaper, followed by two coats of gray primer, two coats of silver paint and two coats of clear acrylic:

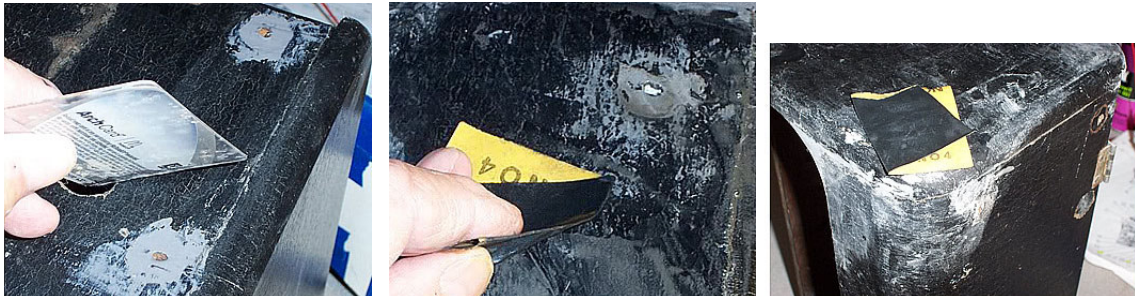
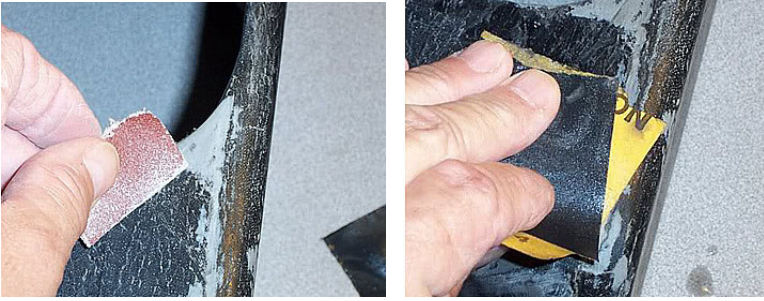
You'll recall that the Stag beneath the four cabinet feet was all but history. It needed to be removed and the four areas cleaned and repaired. So that's what happened. An old, plastic McDonald's gift card smushed in the J-B Weld and smoothed it over. As before, once the Weld was dry everything got a good hand-sanding with 80-grit

paper followed by a light wet-sanding with 400-grit silicon carbide. Be gentle with this sanding business. Easy, easy does it. The light touch reigns supreme.

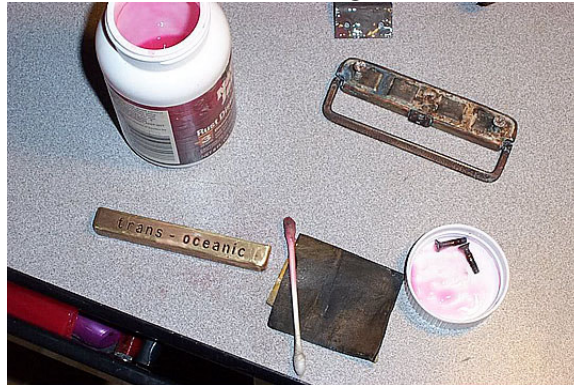
And a little work was done on the lower half of the brass cover latch. Naval Jelly removed the minor rust and a light sanding with 600-grit silicon carbide removed what seemed to be a coating of clear enamel. Brasso did the rest. Big difference.

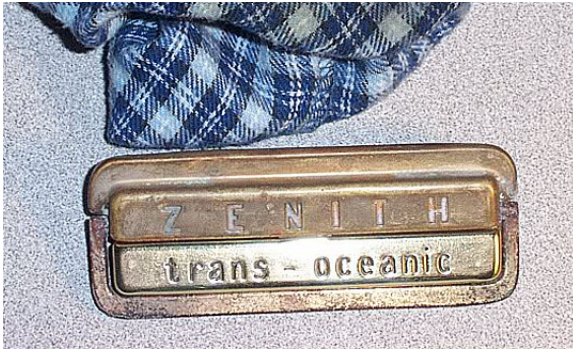
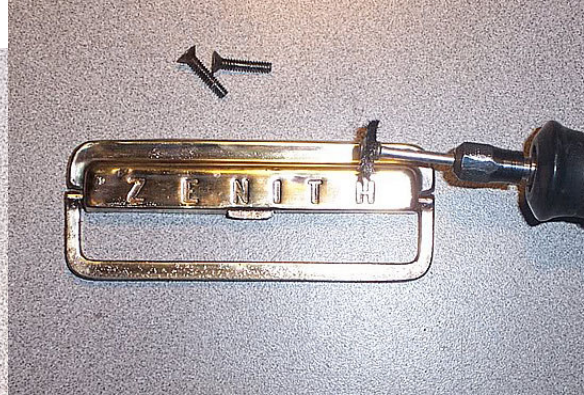
The ole Dremel Tool and wire wheel made quick work of the remaining corrosion and discoloration. What would I do without that thing?:

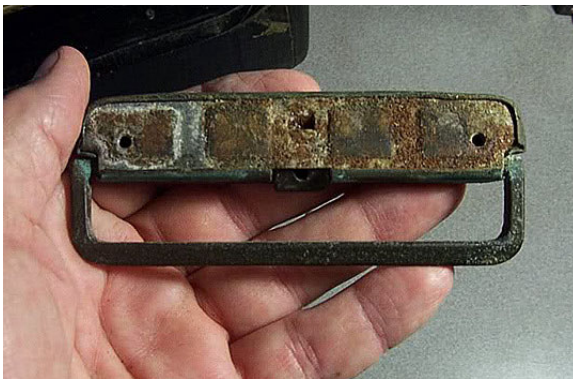
The metal plate on the rear looked worse than it actually was. The wire wheel cleaned it up right fast like:

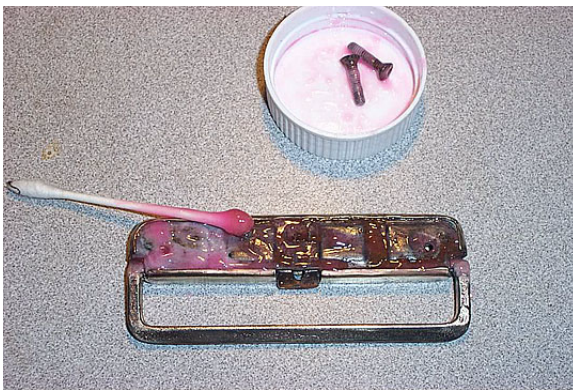
After which of course came the usual Naval Jelly bath:

Looks good, but tomorrow it'll get one more treatment...after the front and bail get a workover with Brasso.

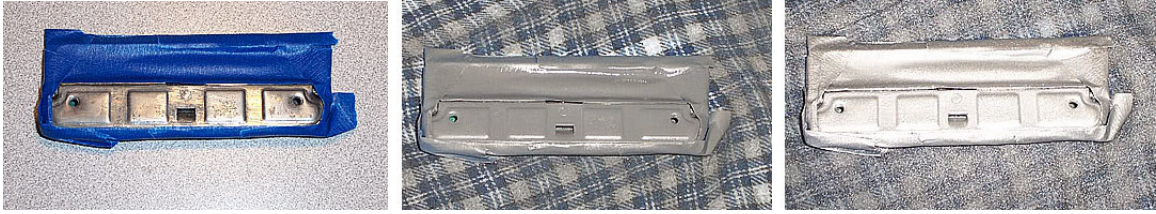
Work continued on the brass cover latch. The rear plate looked even better after a second Naval Jelly treatment, but it remained vulnerable to rust, so something more had to be

done. The answer was a few layers of paint:

First came two coats of gray primer, followed by two coats of metallic silver, then two coats of clear acrylic enamel.

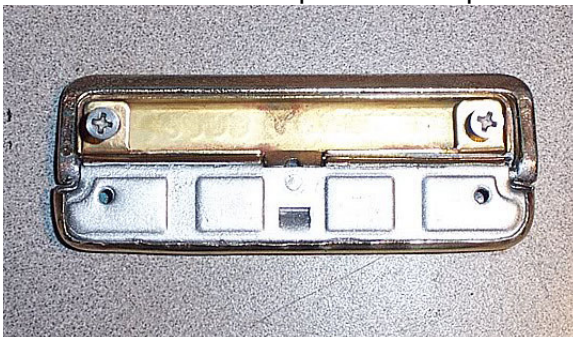
But first, here's the backside of the cover latch without all that tape. There shouldn't be another rust/corrosion problem for quite a while:

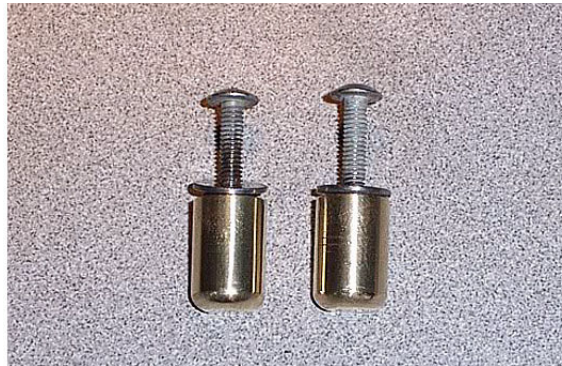
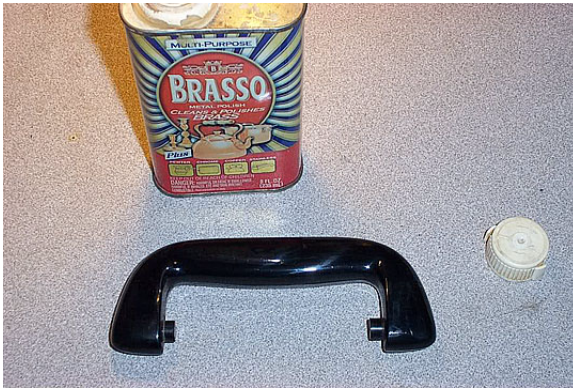
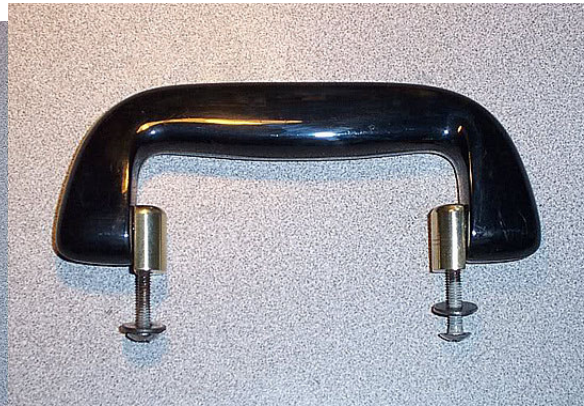
A creature of habit I shall always be, so out came the Dremel Tool and both carrying handle mounting studs were given the works with the wire wheel. Then came a good lick

with Brasso. Almost like new. The carrying handle also got the Brasso once-over. The stuff does wonders to plastic. I have no first hand experience, but I hear it also perks up Bakelite:

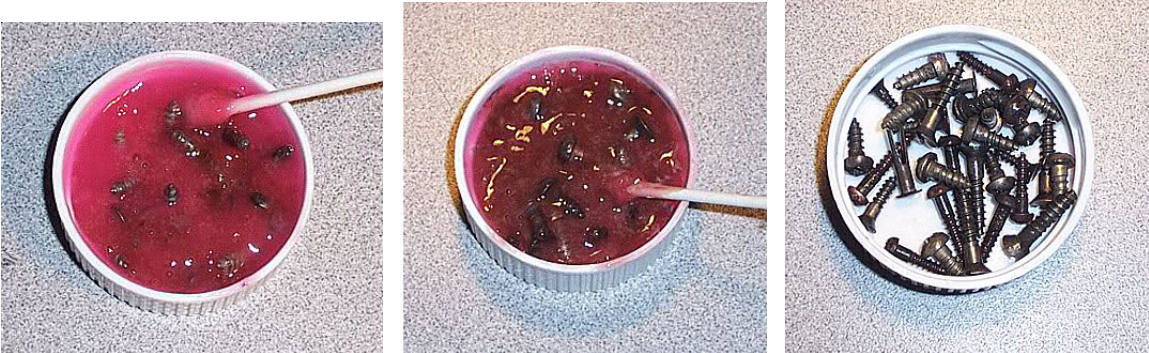
Rusty screws are always an issue. Just completely cover them with Naval Jelly and let them soak for hours...stirring them now and then. This bunch soaked for 10 hours. The brown color pretty much tells you when they're ready to come out. Piece of cake:

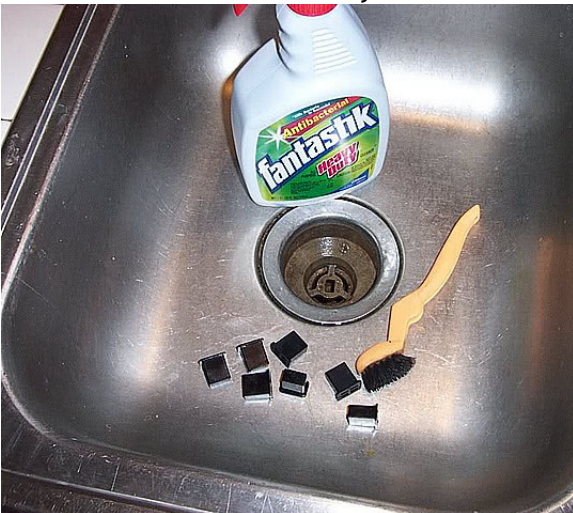
The wife's Fantastic and a nylon brush cleaned up the seven plastic bandswitch buttons:

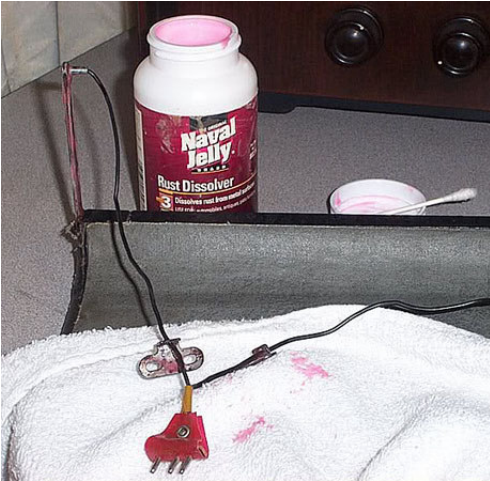
The clamps that hold the cover swing arms in place were also de-rusted, then given two coats of clear enamel:

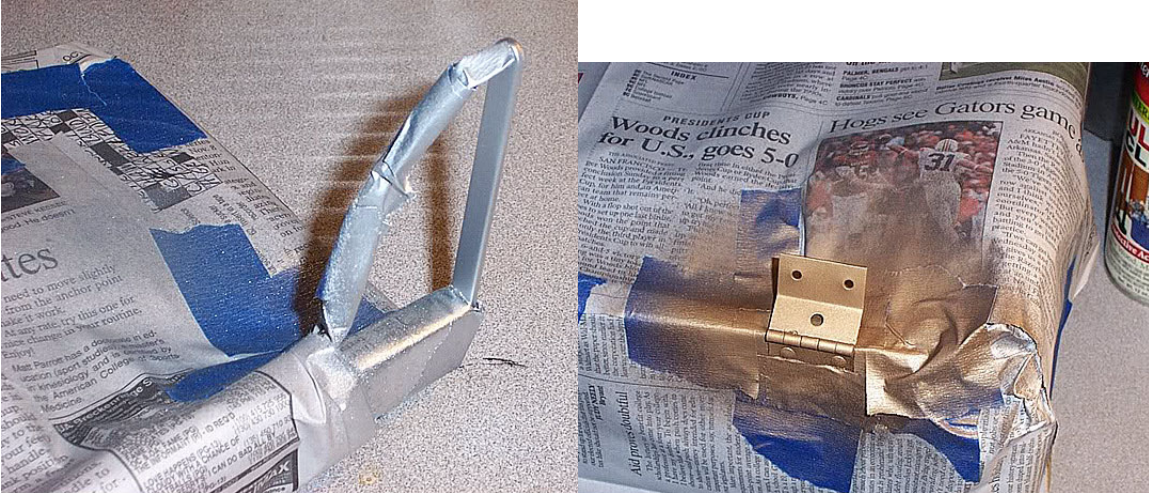
The arms were painted silver, (and) the rear door hinges were painted gold:

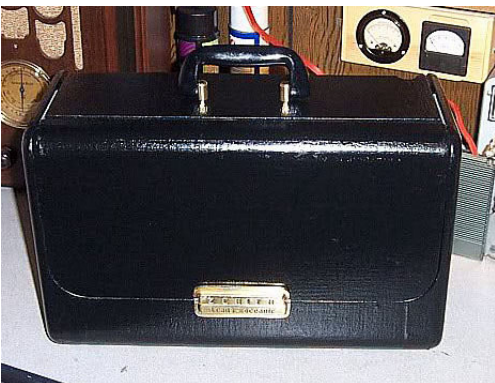
The carrying handle was installed and the cabinet partially reassembled. Here and there a few blemishes remain, but they're nothing to write home about. Here's where we now stand:
